REPORT

Court of Investigation

Into the
Grounding of MV M/V Wakashio Off Pointe d'Esny on 25th July
2020

**REPORT ON THE CASUALTY INVESTIGATION OF THE GROUNDING OF
M/V M/V WAKASHIO OFF THE COAST OF MAURITIUS ON 25 JULY 2020
BY THE COURT OF INVESTIGATION INSTITUTED UNDER SECTION 10 OF
THE MERCHANT SHIPPING ACT 2007**

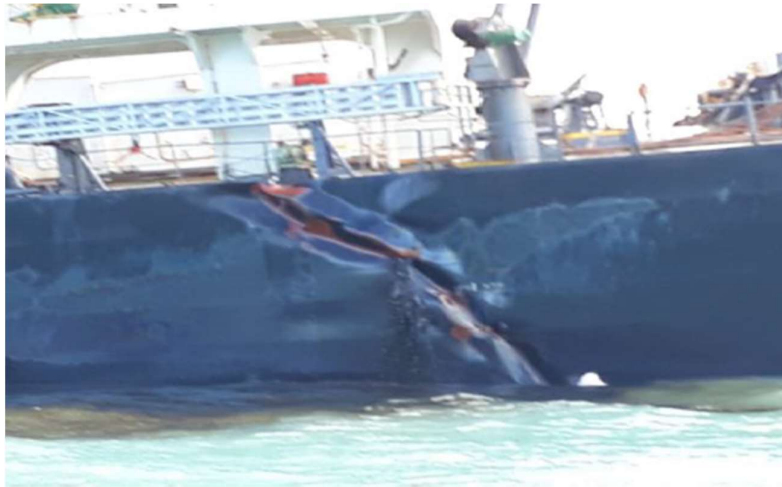
On the following days the vessel was at the mercy of stormy weather and salvors tried to stabilize her by filling hold N° 8 with sea water on the 2nd of August. Cracks started to develop just after the forward of the accommodations, followed by multiple cracks in the hull structure of the vessel which finally broke into two parts causing a spill of heavy oil of an estimated amount of 1000 T.

Aerial view of M/V M/V Wakashio on 8th of August 2020. Courtesy of Ministry of Blue Economy, Marine Resources, Fisheries and Shipping

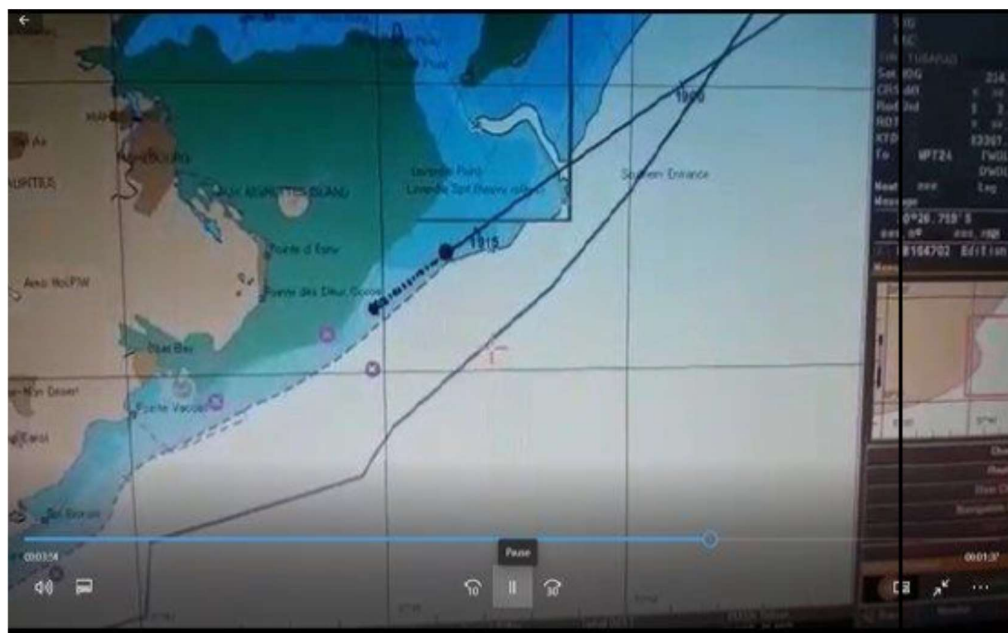
VDR Recording at 19:17 LT

When it became clear to the Master that the vessel was sailing too close to land at 19:17 “We are very very close to land. Just one and a half mile” he should have taken the command as required by company procedures to steer the ship off the dangerous track. Yet it seemed that the Master did not consider the situation to be dramatic as he was more concerned with his offer to the Chief Engineer to sit on the pilot chair or the recharge of the Chief Officer’s sim card.

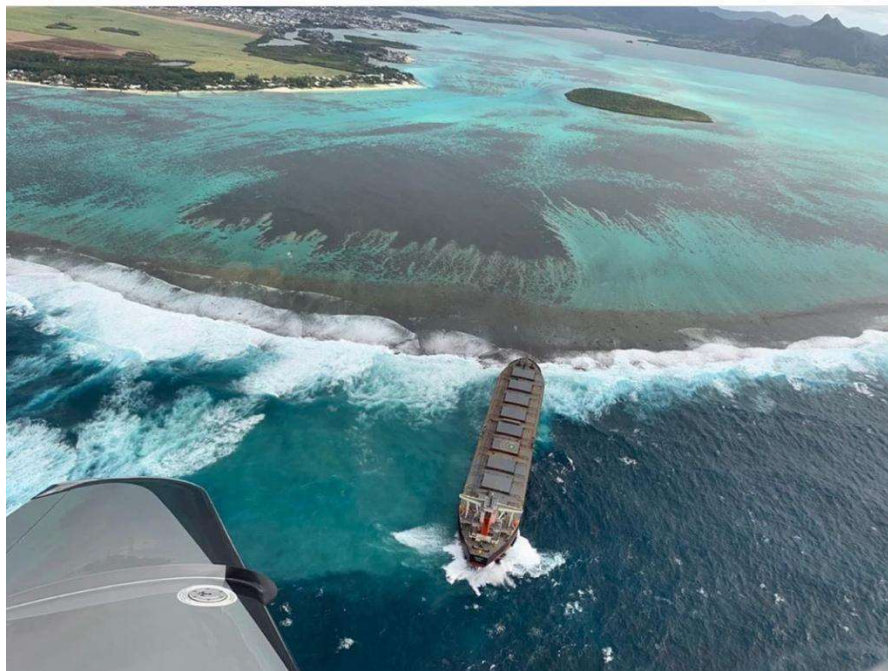
Aerial view of M/V M/V Wakashio on 26th of July 2020. Courtesy of Ministry of Blue Economy, Marine Resources, Fisheries and Shipping

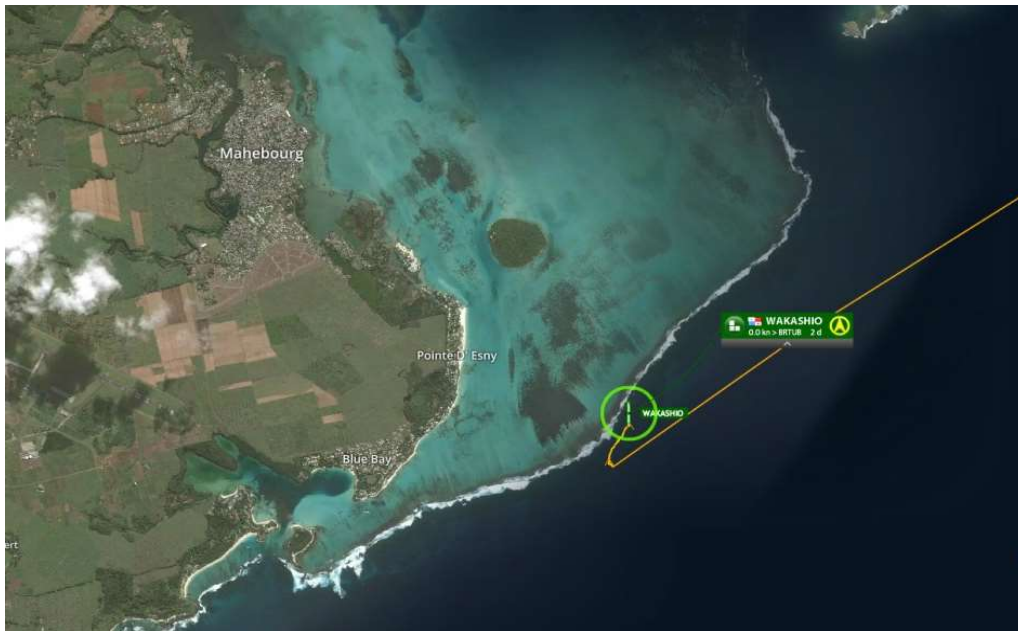
7.2.6 In the meantime during the first week of August, it was seen from reports that the vessel has moved 750 m from the initial grounding position which confirms that the vessel was at times floating although not completely but had adequate bollard pull been available during the time the vessel was swaying due to the combined effect of the SE trade winds and wave motion, the vessel could have been pulled out clear from the reefs or at the very least prevented from moving thereby ensuring her stability while waiting for the sea going tugs on the casualty site.

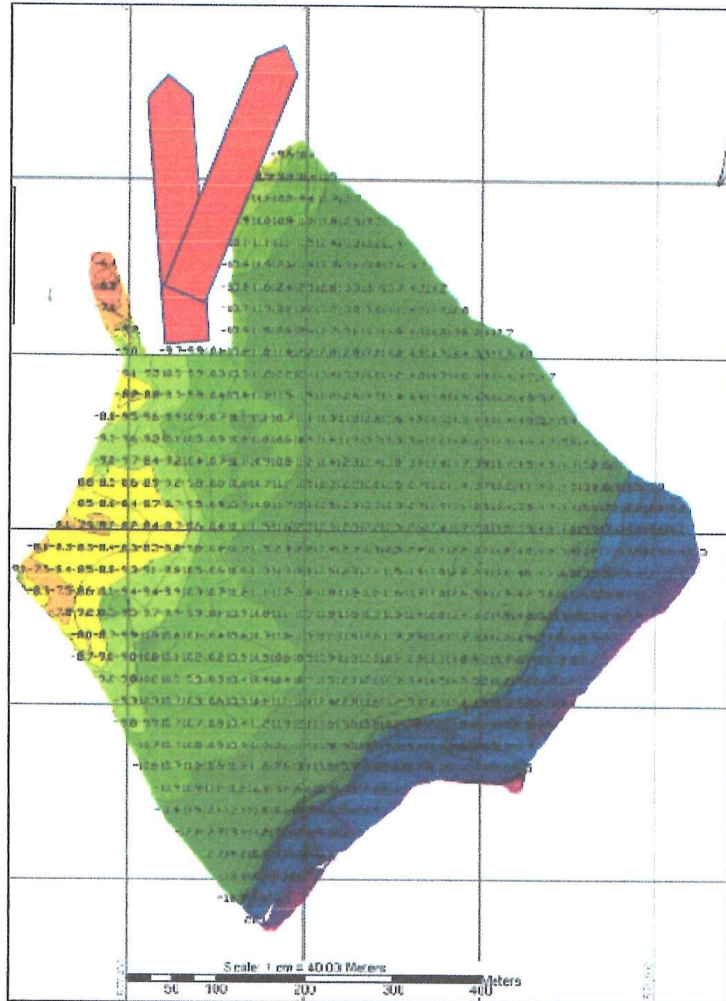
ANNEX IV - BATHYMERIC SURVEY

Bathymetric Survey 29/07/20

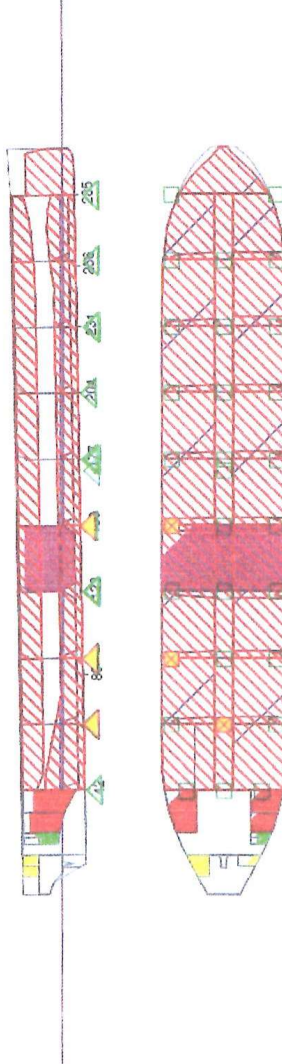
Current Condition Damage Summary

Ground Reaction

Ground Type	Mult. Pins
Total Reaction	6,860 MT
LCR	69,109A m-MS
TCR	4,955P m-BL
Force to Free	10,290 MT
Eff. Friction Coeff.	1.500

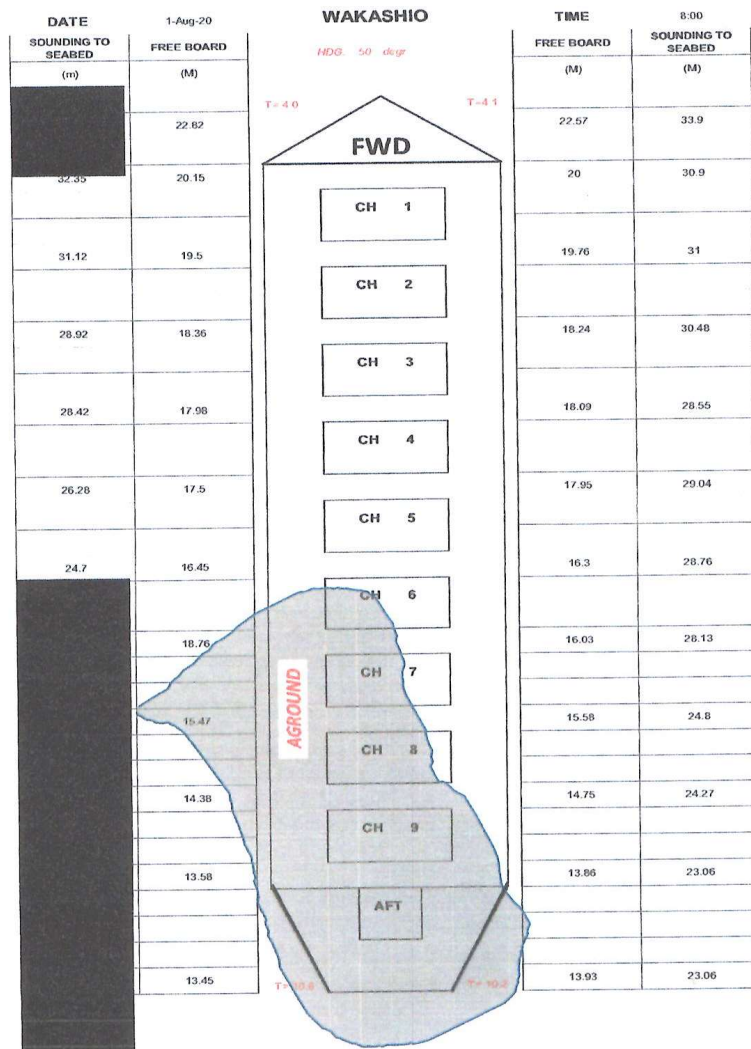
ANNEX VI - Overview of soundings

Overview of soundings and freeboard – 01/08/20.Heading 050°
